FINAL SUMMARY TECHNICAL REPORT

BUREAU OF NAVAL WEAPONS RRMA-232

MATERIALS PROCESSING DEPARTMENT

DESIGN DATA STUDY FOR
COATED COLUMBIUM ALLOYS

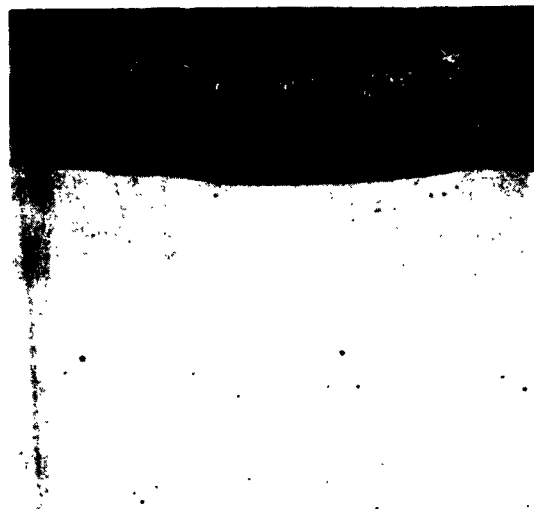
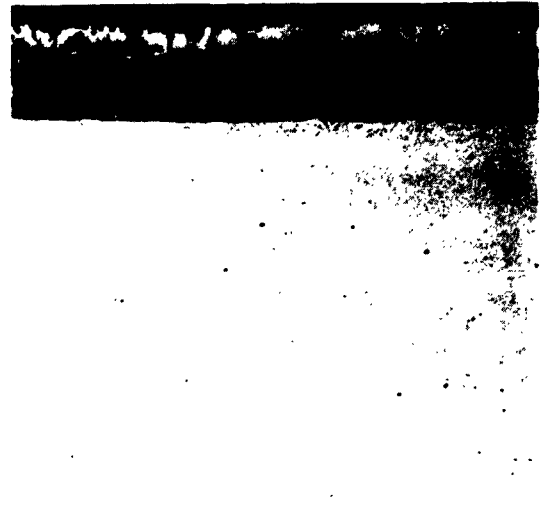
Figure 2 Photomicrographs and Average Coating Thickness Measurements
of Various Coatings on D-114 Alloy in the As Coated Condition
250X

Pronounced differences can also be observed in the microstructures of the six modified silicide type coatings. For example, the chromium surface layer formed during the second coating cycle on the Pratt & Whitney coating, the pre-deposited titanium diffusion zone beneath the GT&E silicide coating and the intermetallic phase and titanium diffusion zone in the substrate beneath the TRW Cr-Ti-Si alloy coating resulting from the Cr-Ti coating cycle prior to the deposition of silicon.

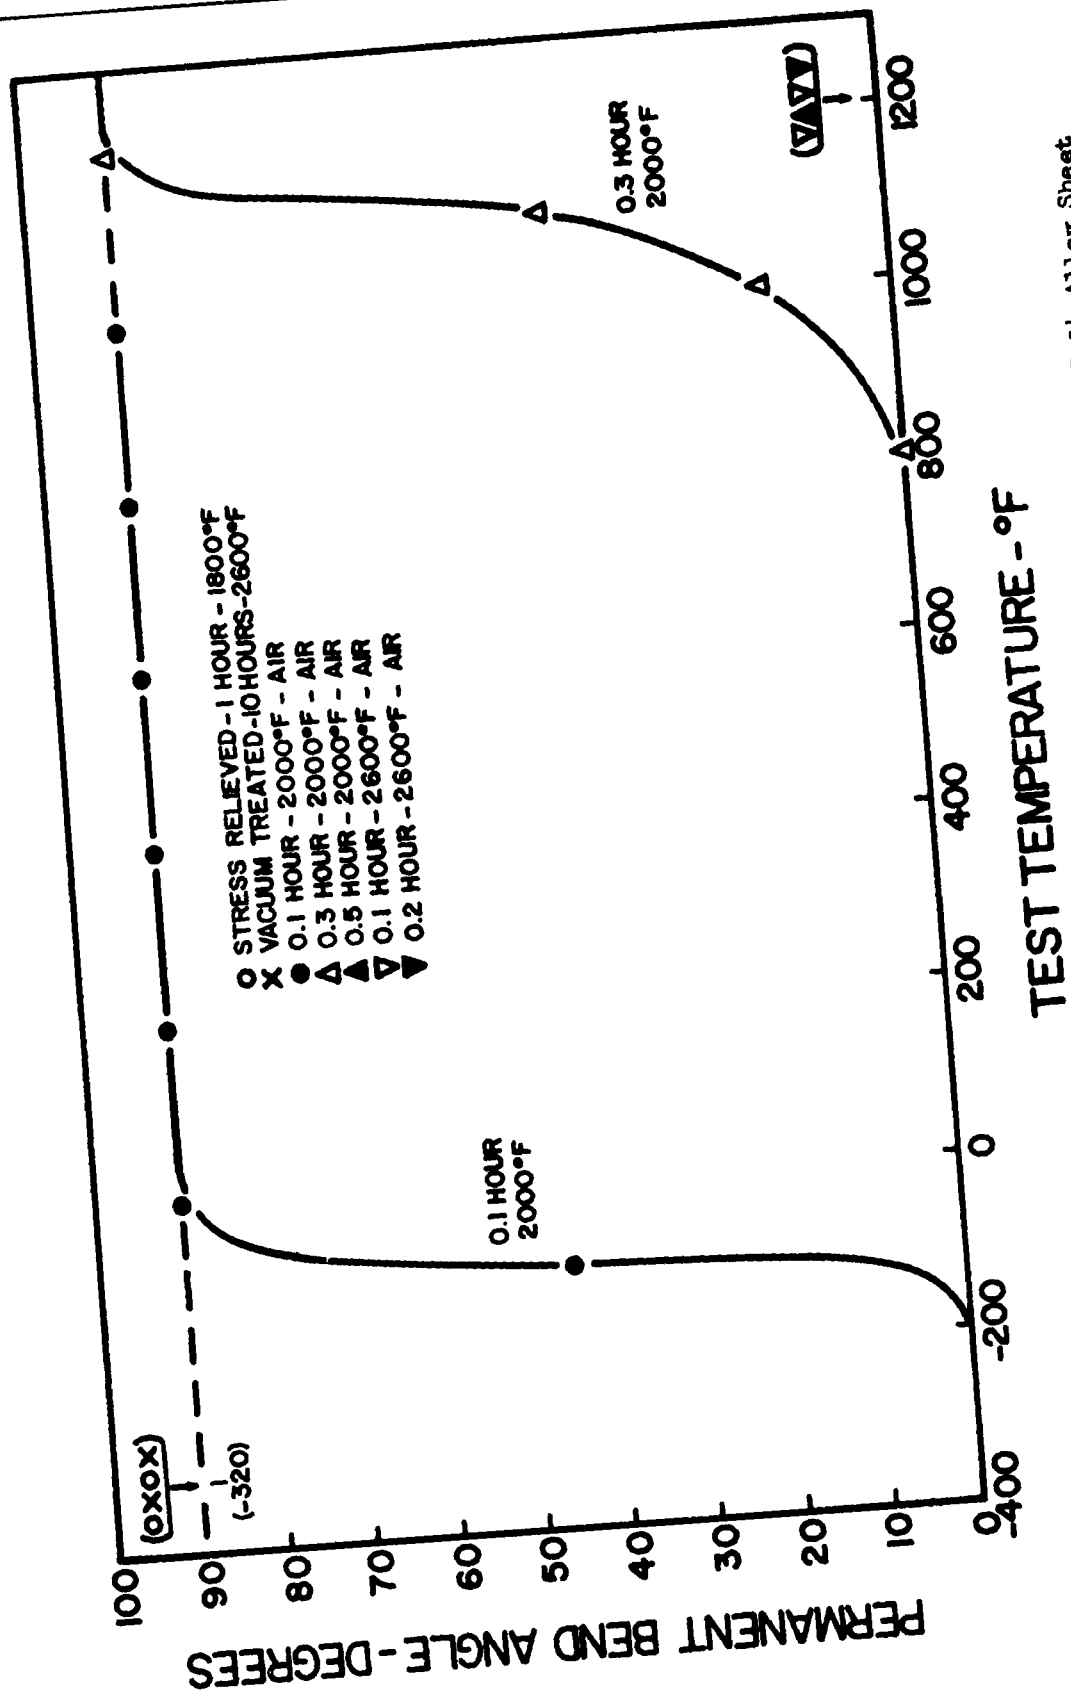
Figure 9 Bend Test Data for Vacuum Heat Treated and Air Oxidized 30 Mil D-14 Alloy Sheet

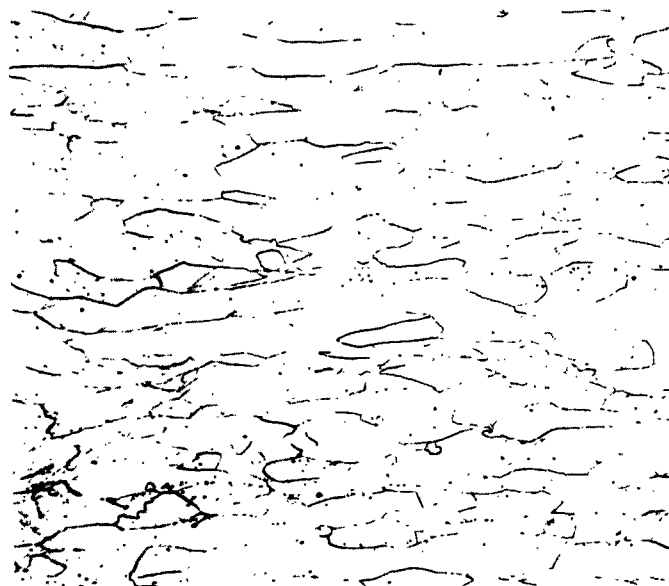
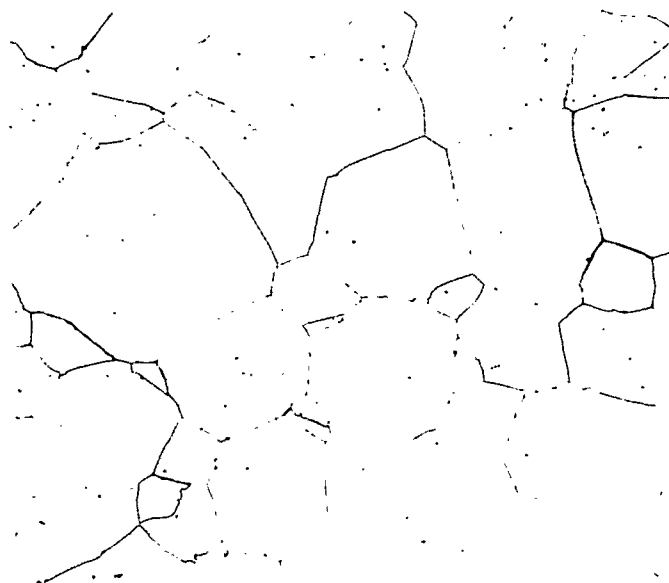
The D-14 alloy was ductile at -320°F both in the stress relieved condition (1 hour at 1800°F) and after 10 hours vacuum heat treatment at 2600°F. Figure 10 shows photomicrographs illustrating the degree of grain growth resulting from the 2600°F heat treatment.

Figure 10 Photomicrographs Showing D-11 Alloy Sheet
Structure as Stress Relieved (1 Hour - 1800°F)
and After Vacuum Heat Treatment for 10 Hours
at 2600°F 250X

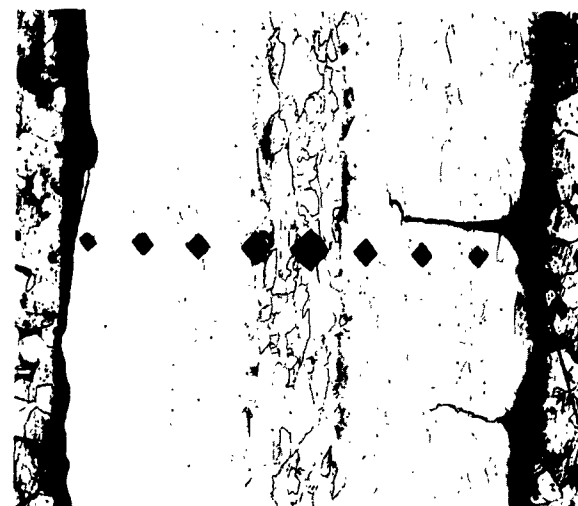
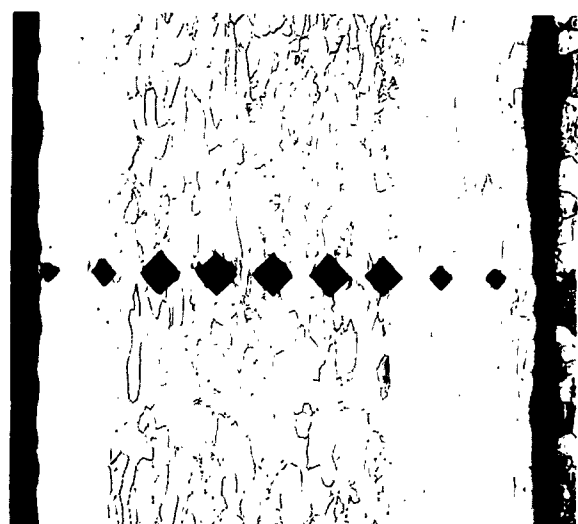
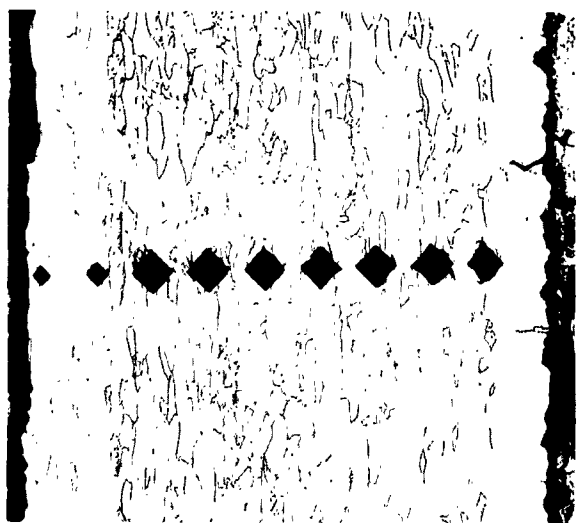
Figure 11 presents photomicrographs of the specimens oxidized at 2000°F. The gross internal penetration of oxygen is observed as the advancing interface of oxygen contaminated substrate across the cross section. Microhardness impressions are shown in the photomicrographs and the hardness values are plotted as a function of distance from the original surface in Figure 12. At 2000°F the D-14 alloy was hardened by oxygen to a depth of 15 mils, completely through the 30 mil sheet, in 0.5 hour. At 2600°F the entire specimen cross section was severely hardened in only 0.1 hour of oxidation.

Figure 11 Photomicrographs Showing Oxygen Penetration in 30 Mil
D-114 Alloy Sheet Oxidized in Air at 2000°F 100X

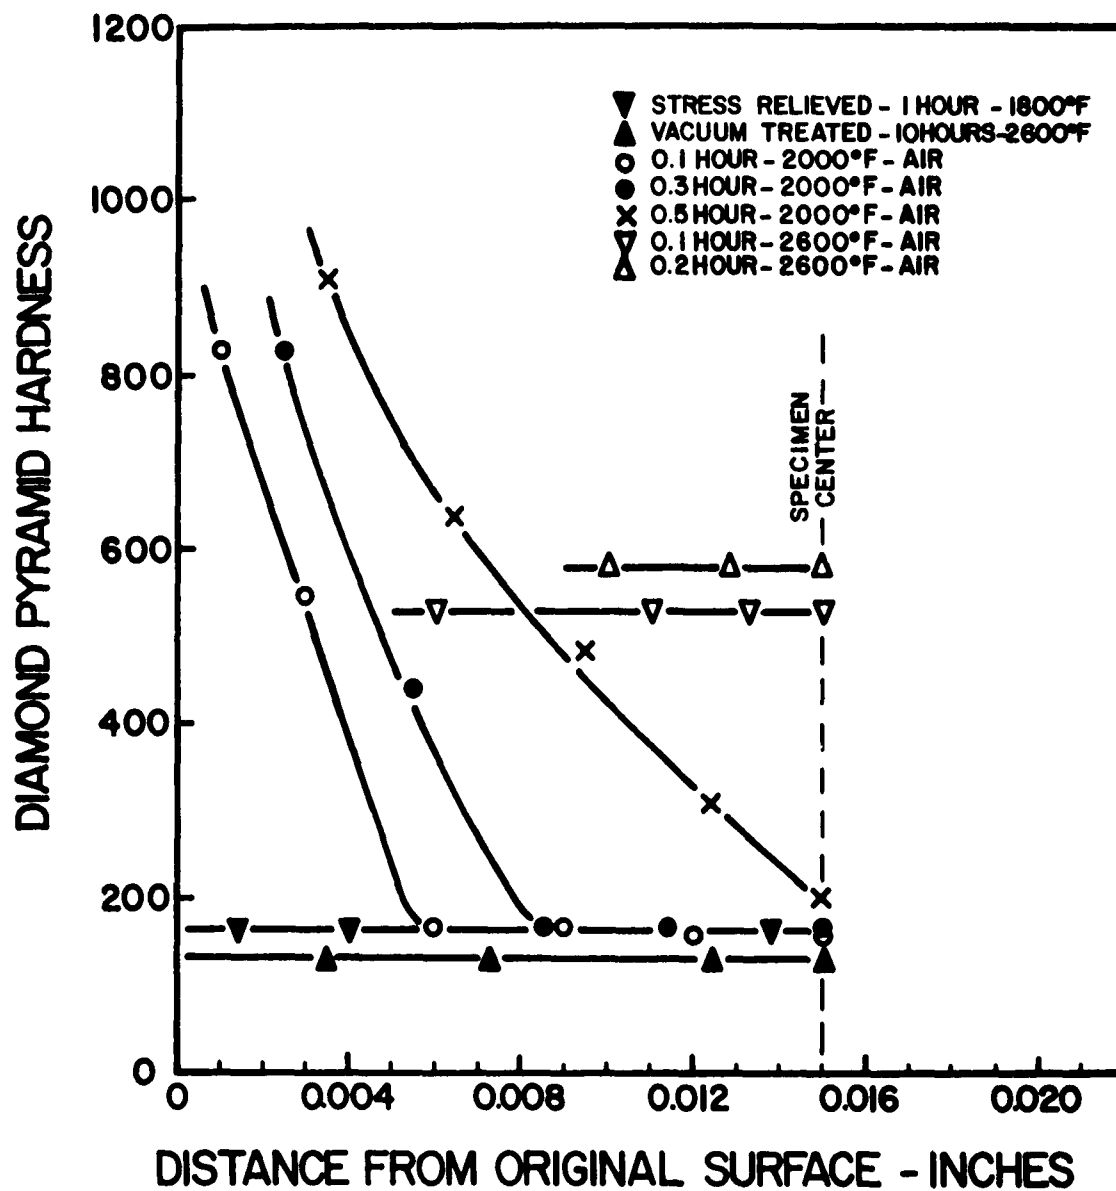
Figure 12 Microhardness Traverses Across 30 Mil D-11 Alloy Sheet for Heat Treated and Oxidized Conditions

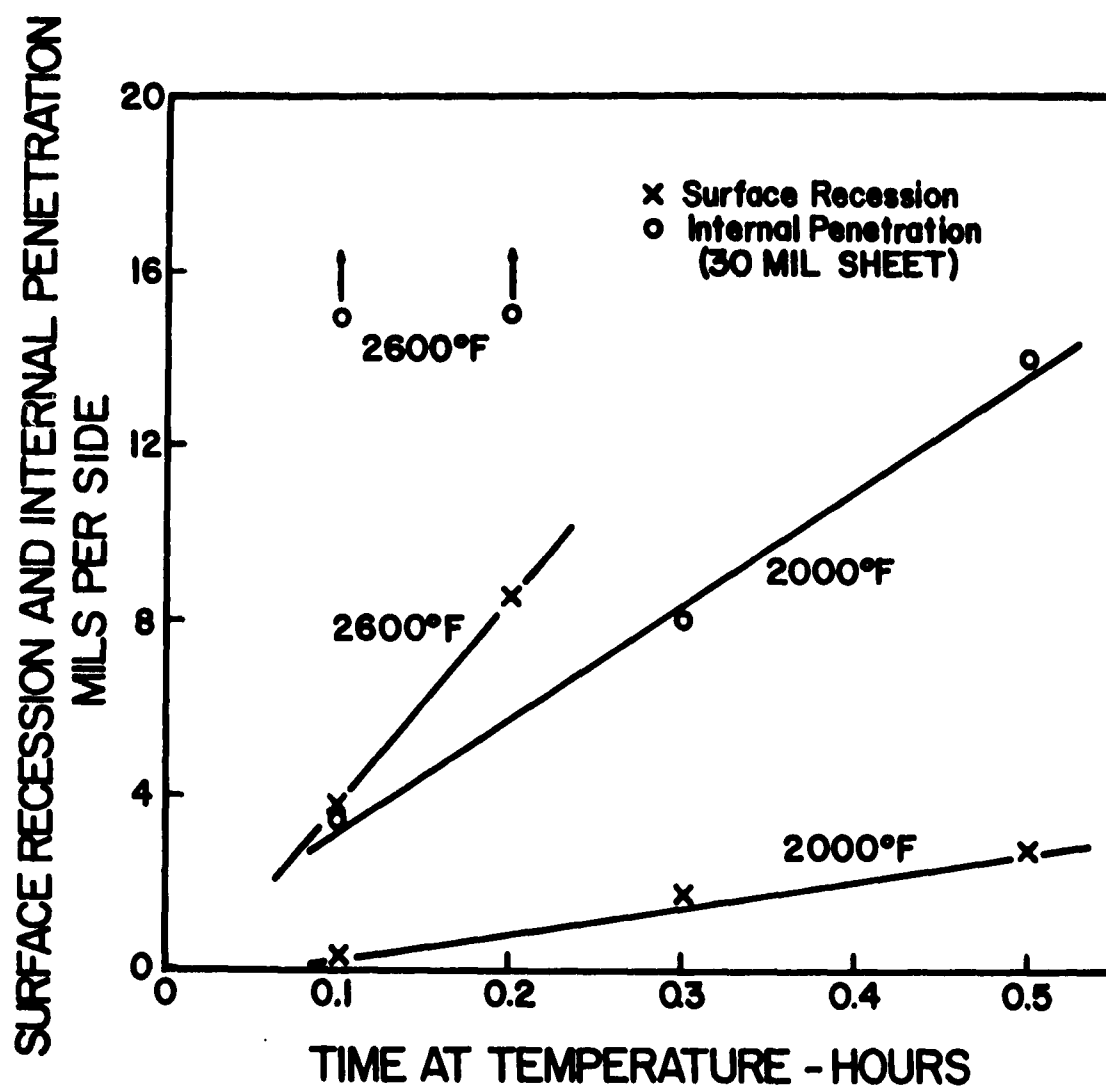
Figure 13 is a plot of internal oxygen contamination and cross sectional surface recession as a function of time at 2000 and 2600°F. Internal penetration was taken as the depth of the metallographically observed interface which was produced on polishing by the differential hardness. This interface was not quite coincident with the depth of contamination indicated by the microhardness traverses. Surface recession, resulting from conversion of the base metal to an oxide scale, increased by a factor of approximately 10 from 2000 to 2600°F.

Figure 13 Surface Recession and Internal Penetration for Oxidized D-14 Alloy as a Function of Time at 2000 and 2600°F

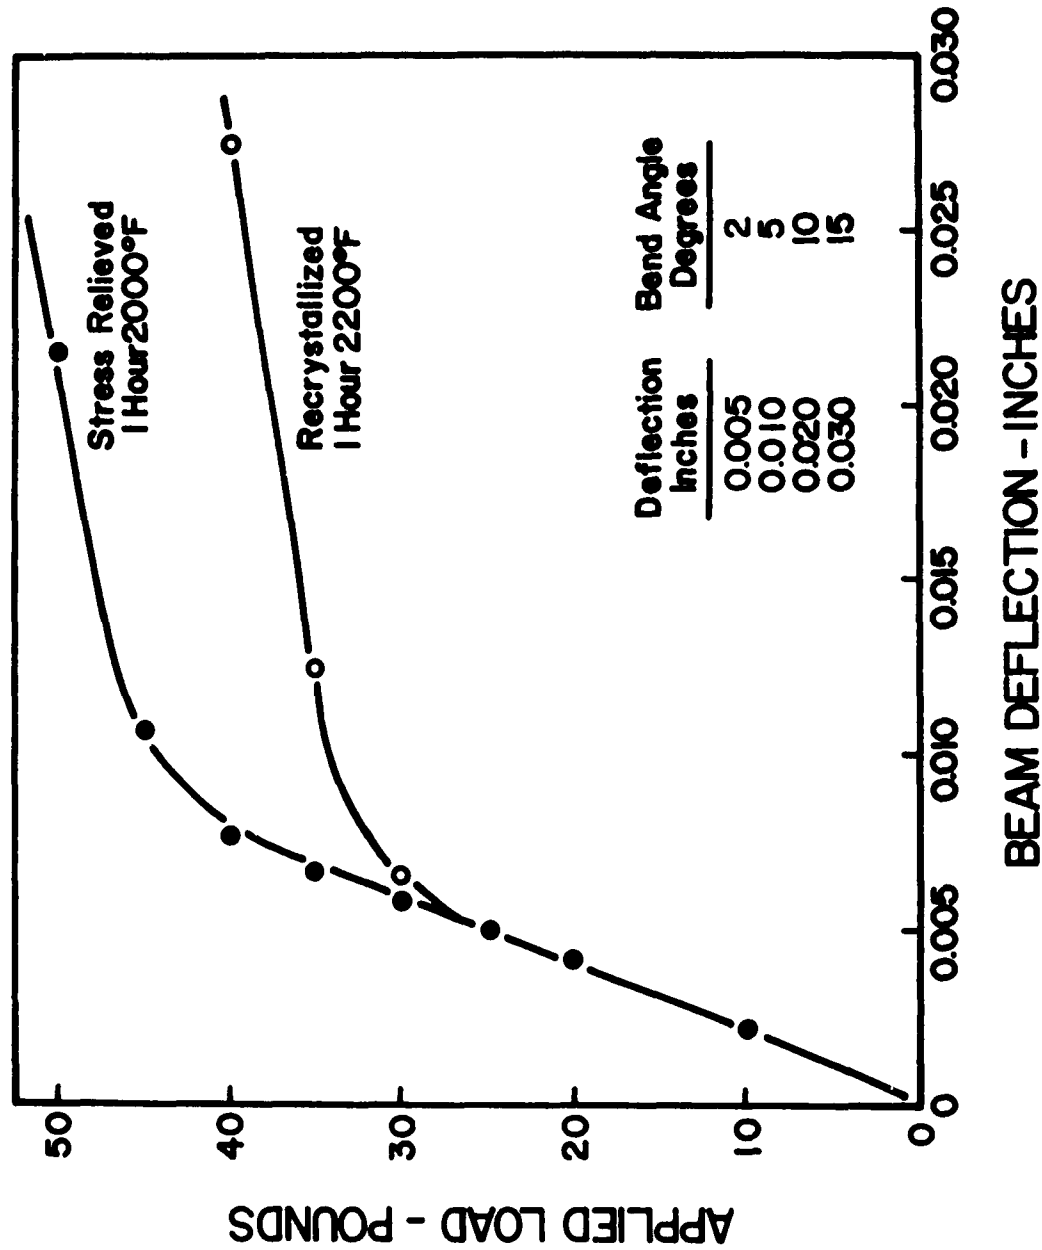
Figure 17 Beam Deflection as a Function of Applied Load for
D-114 Alloy Stressed in the Bend Test Apparatus

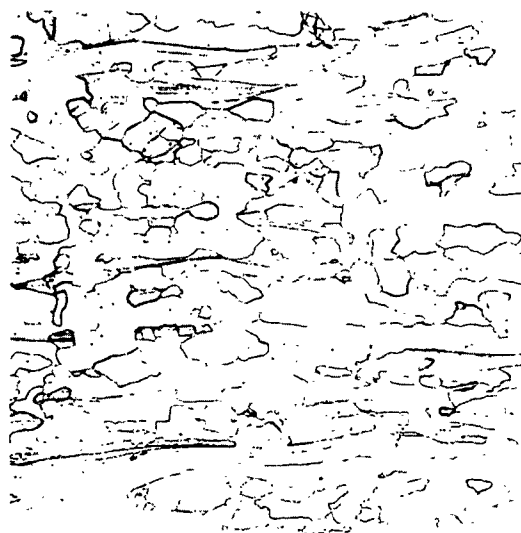
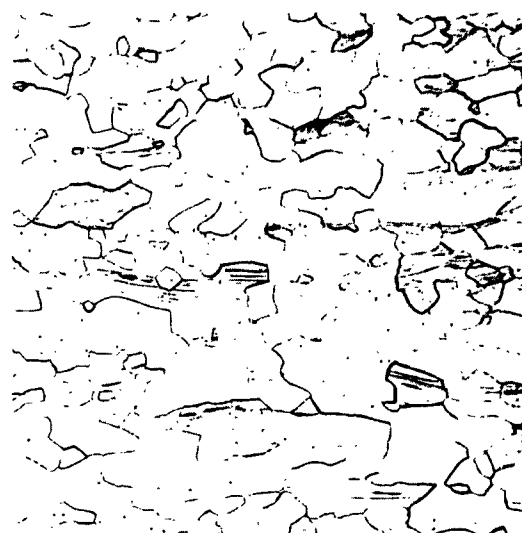
Figure 25 FS-85 Alloy as Received, after Recrystallization
for 1 Hour at 2300°F and as Cr-Ti-Si Coated 250X

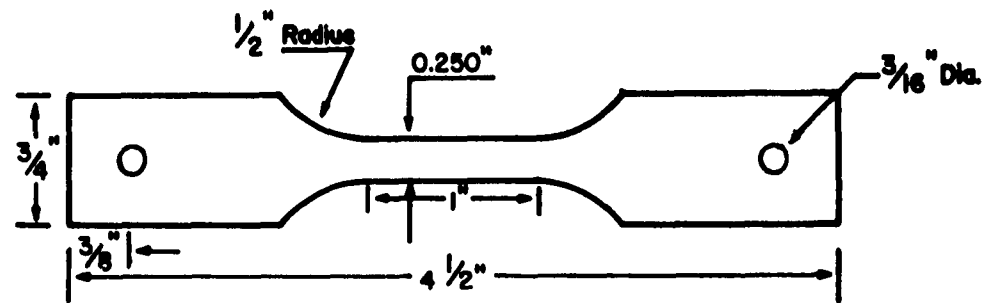
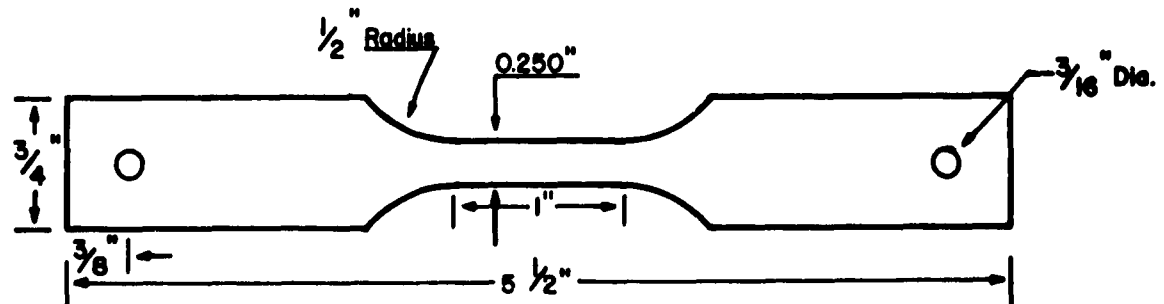
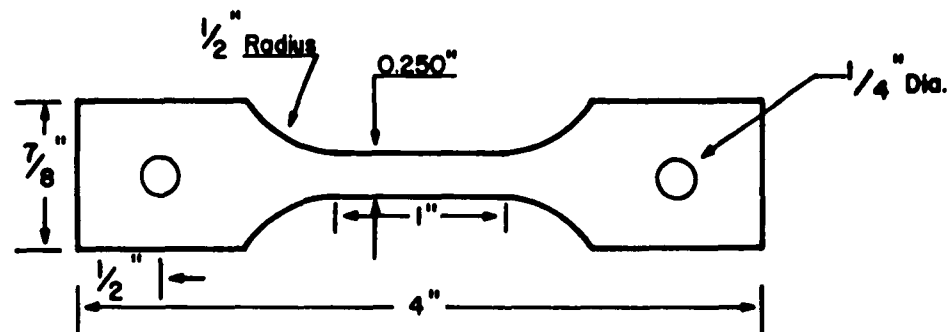
A · TENSILE SPECIMEN - RT to 2300°F

B · TENSILE SPECIMEN - 2500 and 2600°F

C · STRESS RUPTURE SPECIMEN

Figure 26 Drawings of Tensile and Stress Rupture Specimen Configurations Used in the Design Data Study

- 1) Machined various specimen configurations shown in Figure 26
- 2) Produced uniform radii on all specimen edges and corners by an abrasive tumbling technique
- 3) Degreased in trichloroethylene
- 4) Lightly etched in an HF-HNO₃-H₂SO₄ aqueous solution and rinsed in water
- 5) Recrystallized in vacuum for 1 hour at 2300°F.

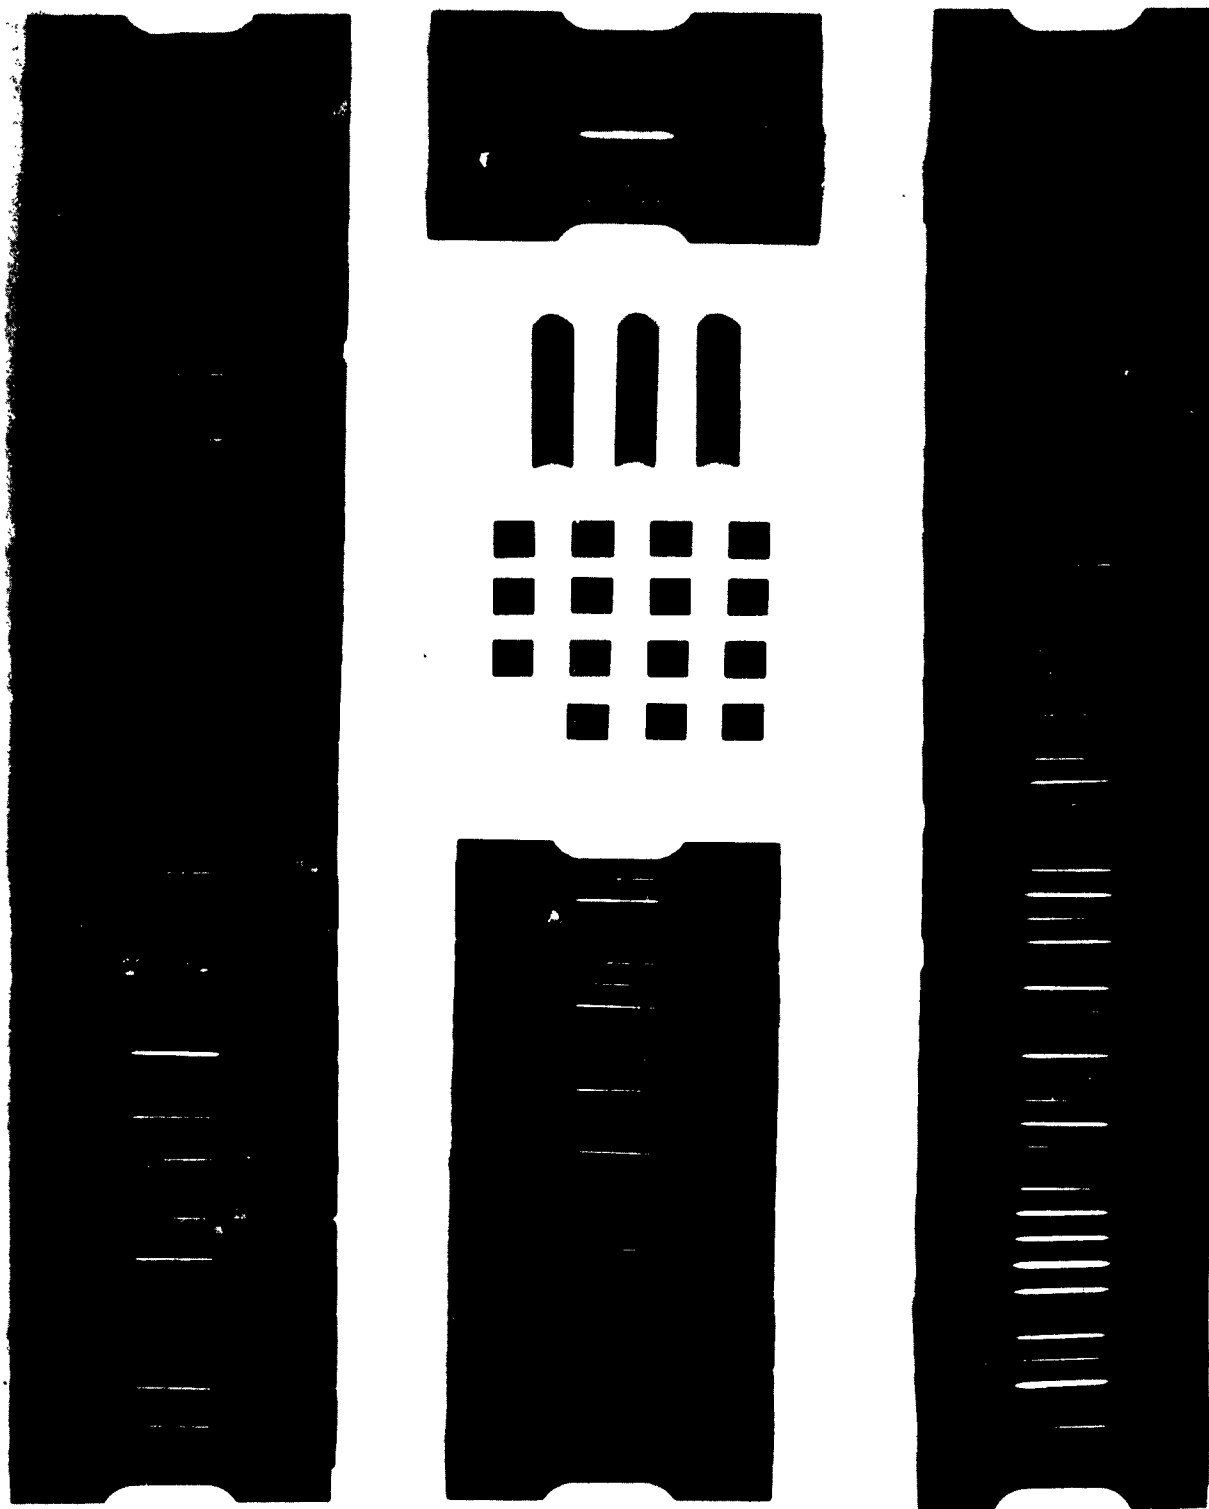
Figure 27 Photograph of FS-85 Alloy Evaluation
Specimens Coated by Pfaudler Company
Approximately 1/3X

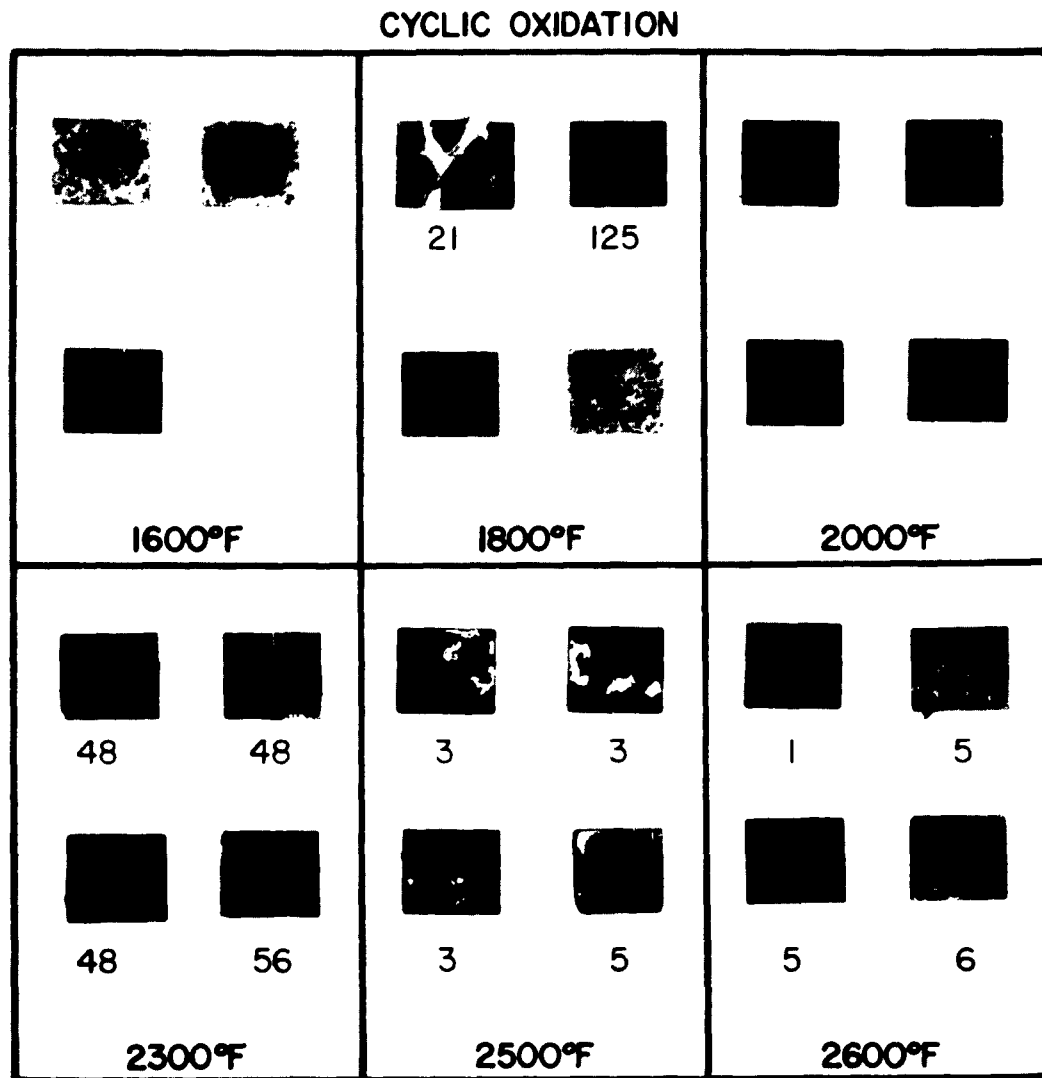
Figure 30 Pfautler Coated FS-85 Alloy Specimens Cyclic Oxidation Tested
in Air at Temperatures from 1600-2600°F

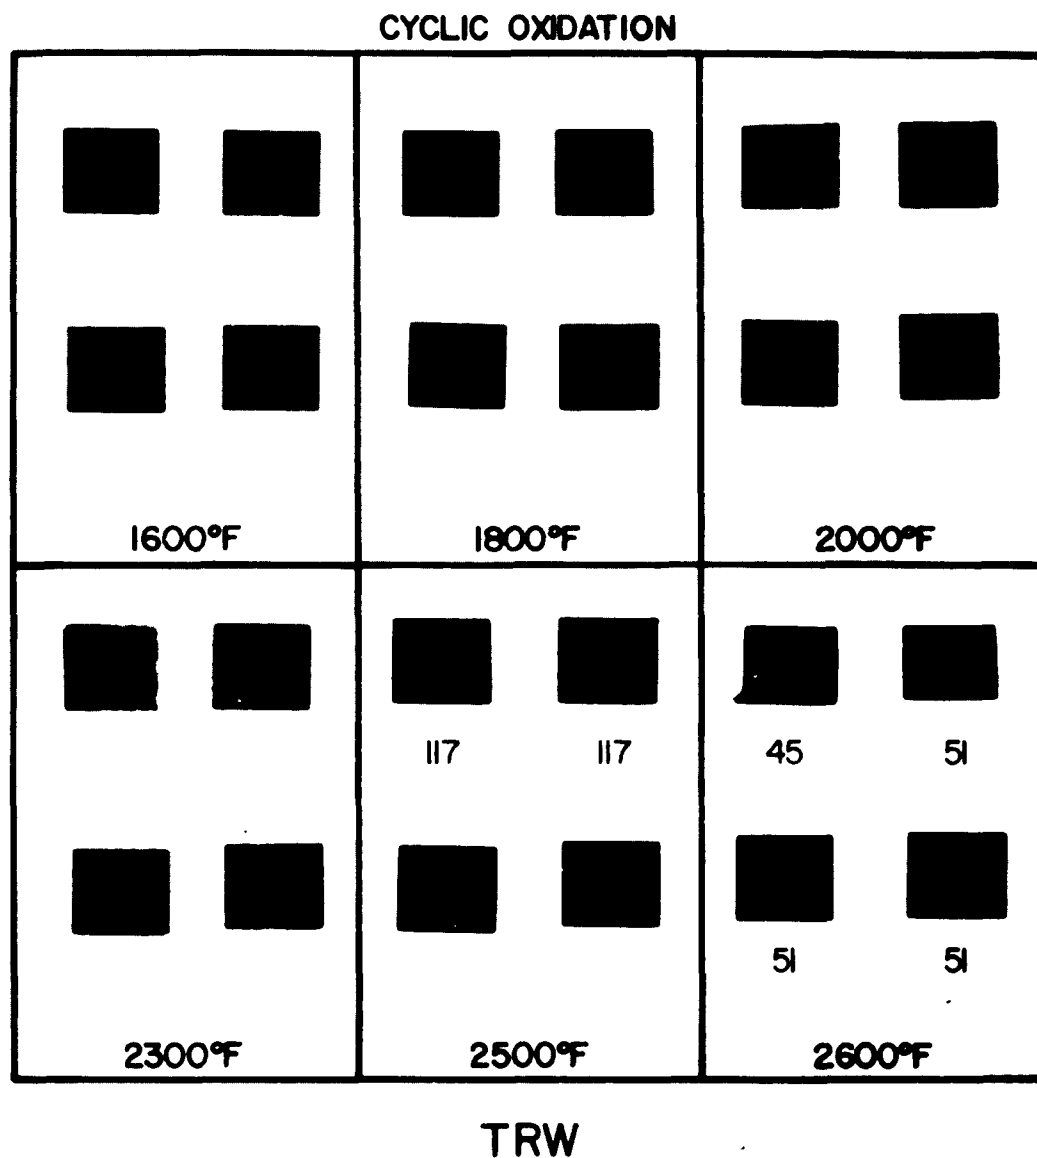
Figure 31 TRW Coated FS-85 Alloy Specimens Cyclic Oxidation Tested in
Air at Temperatures from 1600-2600°F 1X

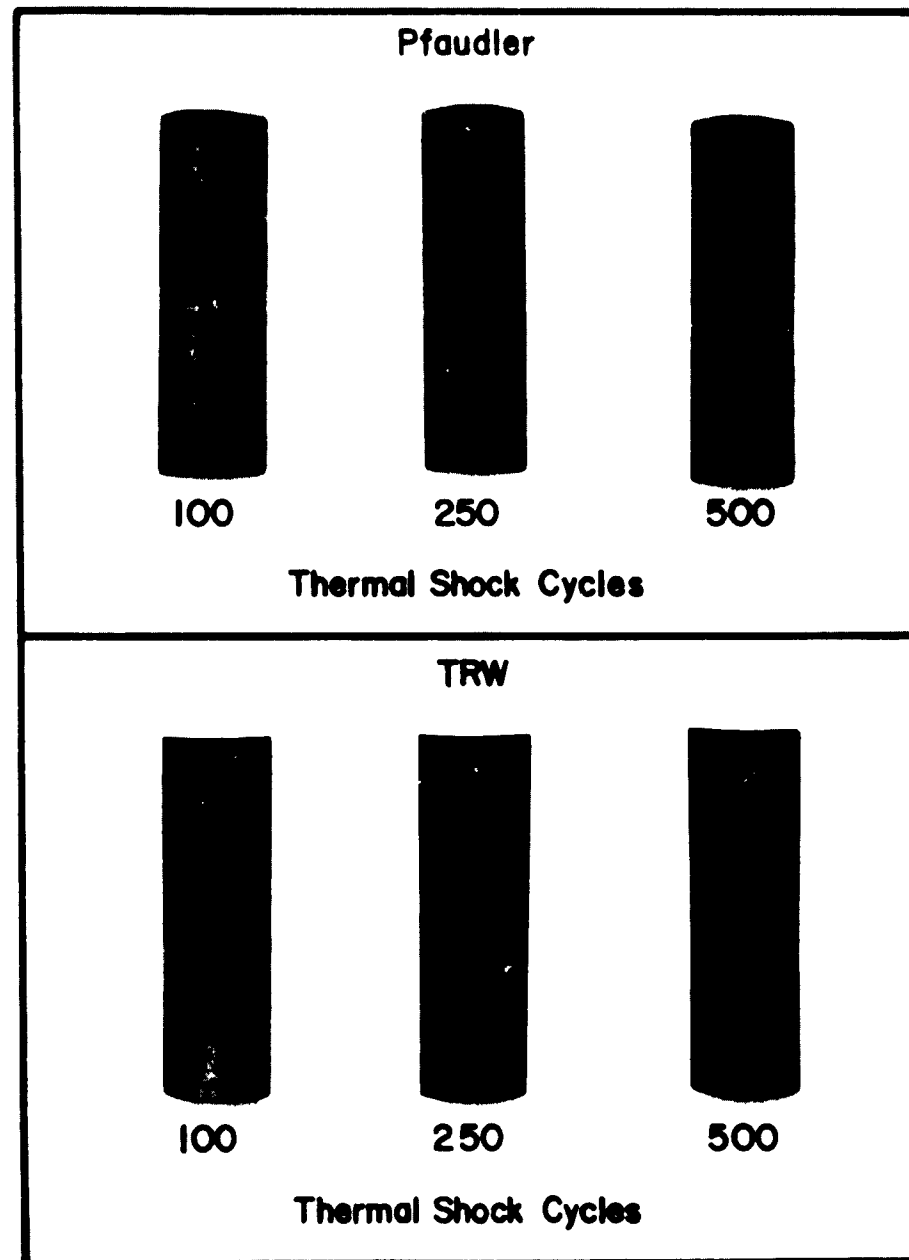
Figure 33 Pfaudler and TRW Coated FS-85 Alloy Specimens Thermal
Shock Tested by Cycling from 2600 to 250°F 1X

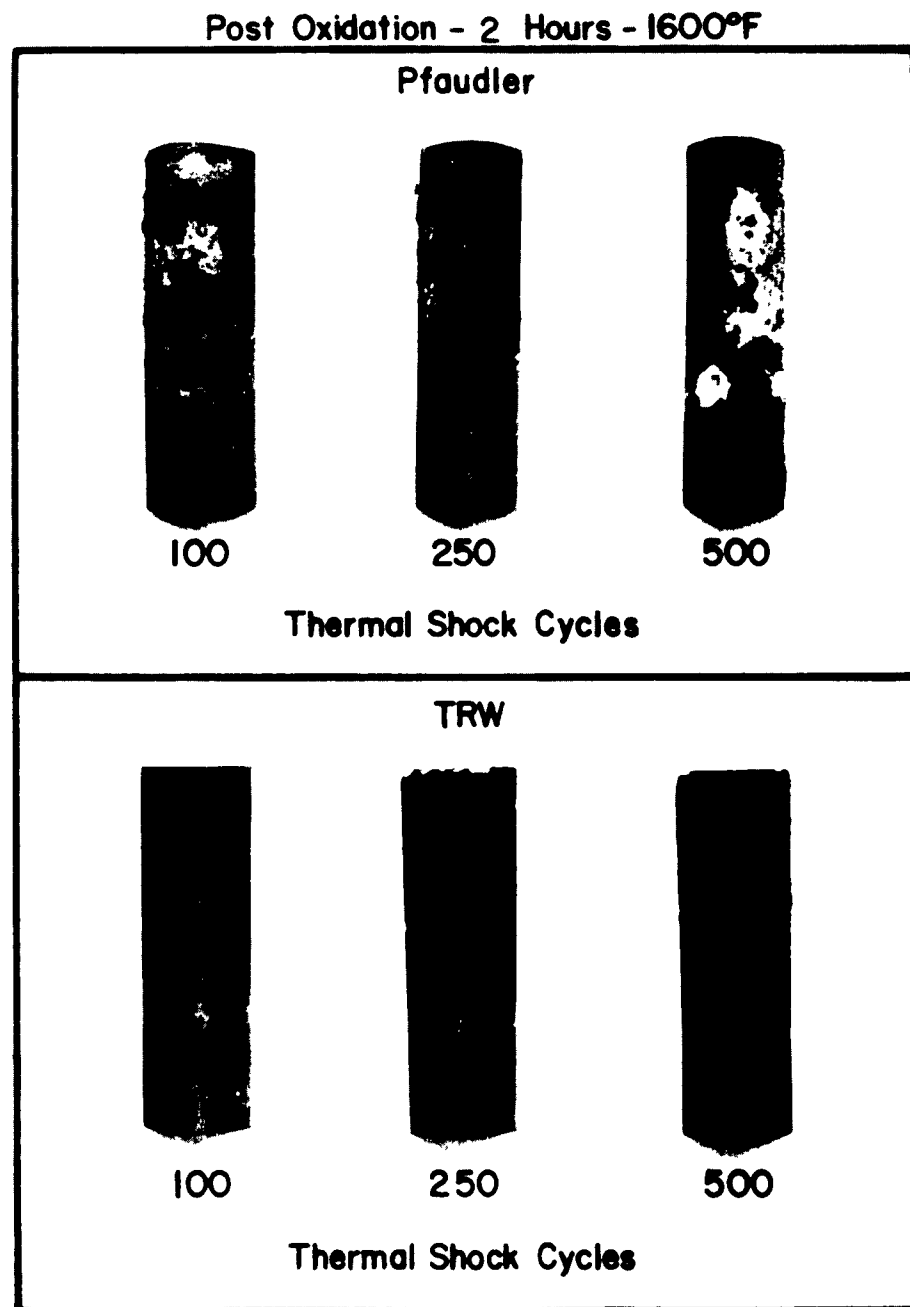
Figure 34 Pfudler and TRW Coated FS-85 Alloy Specimens
Thermal Shock Tested by Cycling from 2600 to
250°F, Followed by Post Oxidation for 2 Hours
at 1600°F

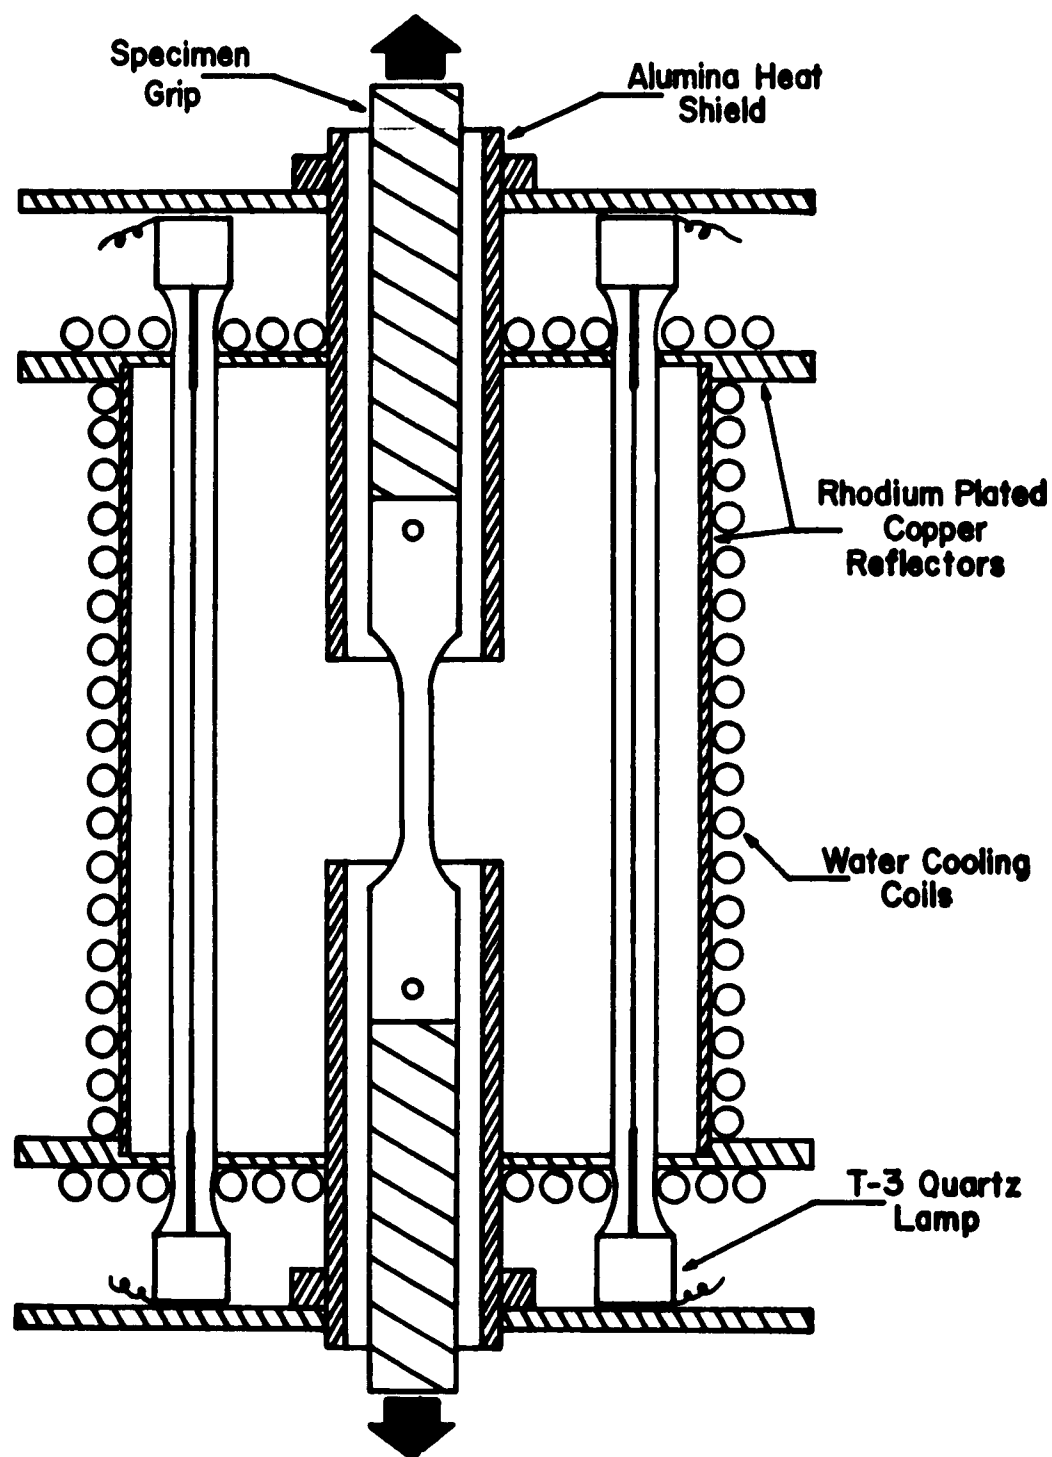
Figure 35 Cross Section of Quartz Lamp Radiant Heated Furnace for Heating Tensile Test Specimens

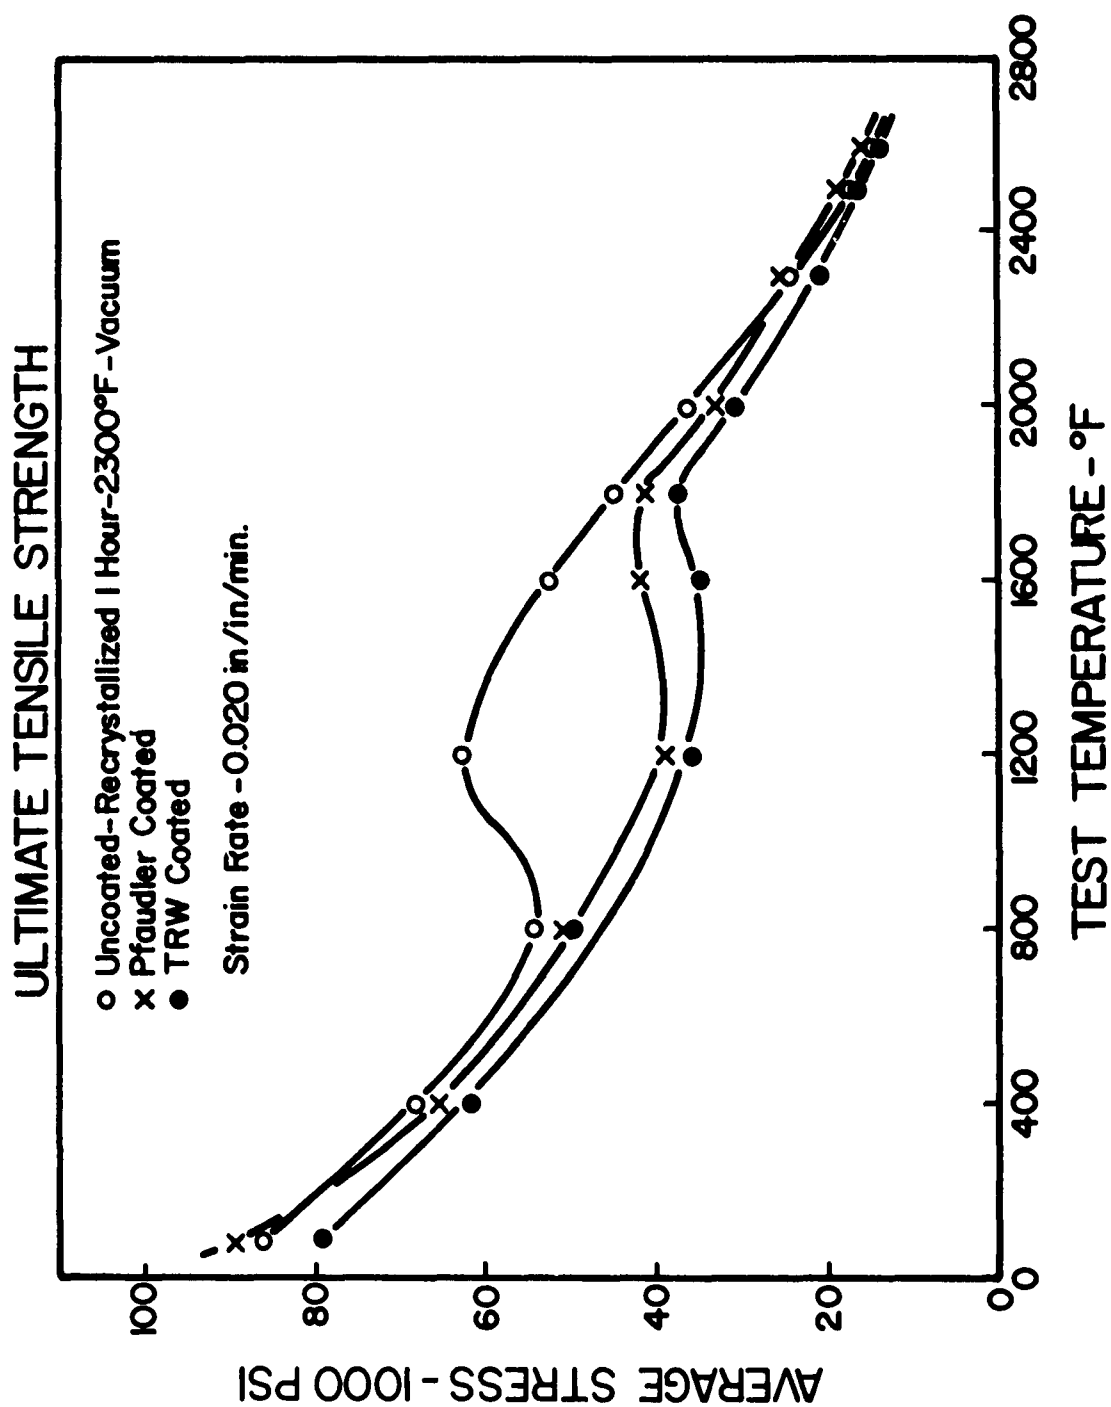
Figure 37 Ultimate Tensile Strength of Uncoated and Coated 30 Mil FS-85 Alloy Sheet from Room Temperature to 2600°F

Tables 9, 10 and 11 list the mechanical property data from this investigation and the properties are plotted as a function of the test temperature in the form of comparative curves in Figures 37 through 40. In general the tensile and yield strengths of the coated FS-85 alloy sheet tested in air were less than those of the uncoated sheet tested in vacuum, however, only in the temperature range from 800 to 1600°F was this differential more than about 5-10%. Original uncoated specimen dimensions were used for the strength calculations with no attempt to compensate for loss of base metal load bearing cross section due to the coating formation. This could account for as much as a 10% apparent reduction in the ultimate tensile and yield strengths.

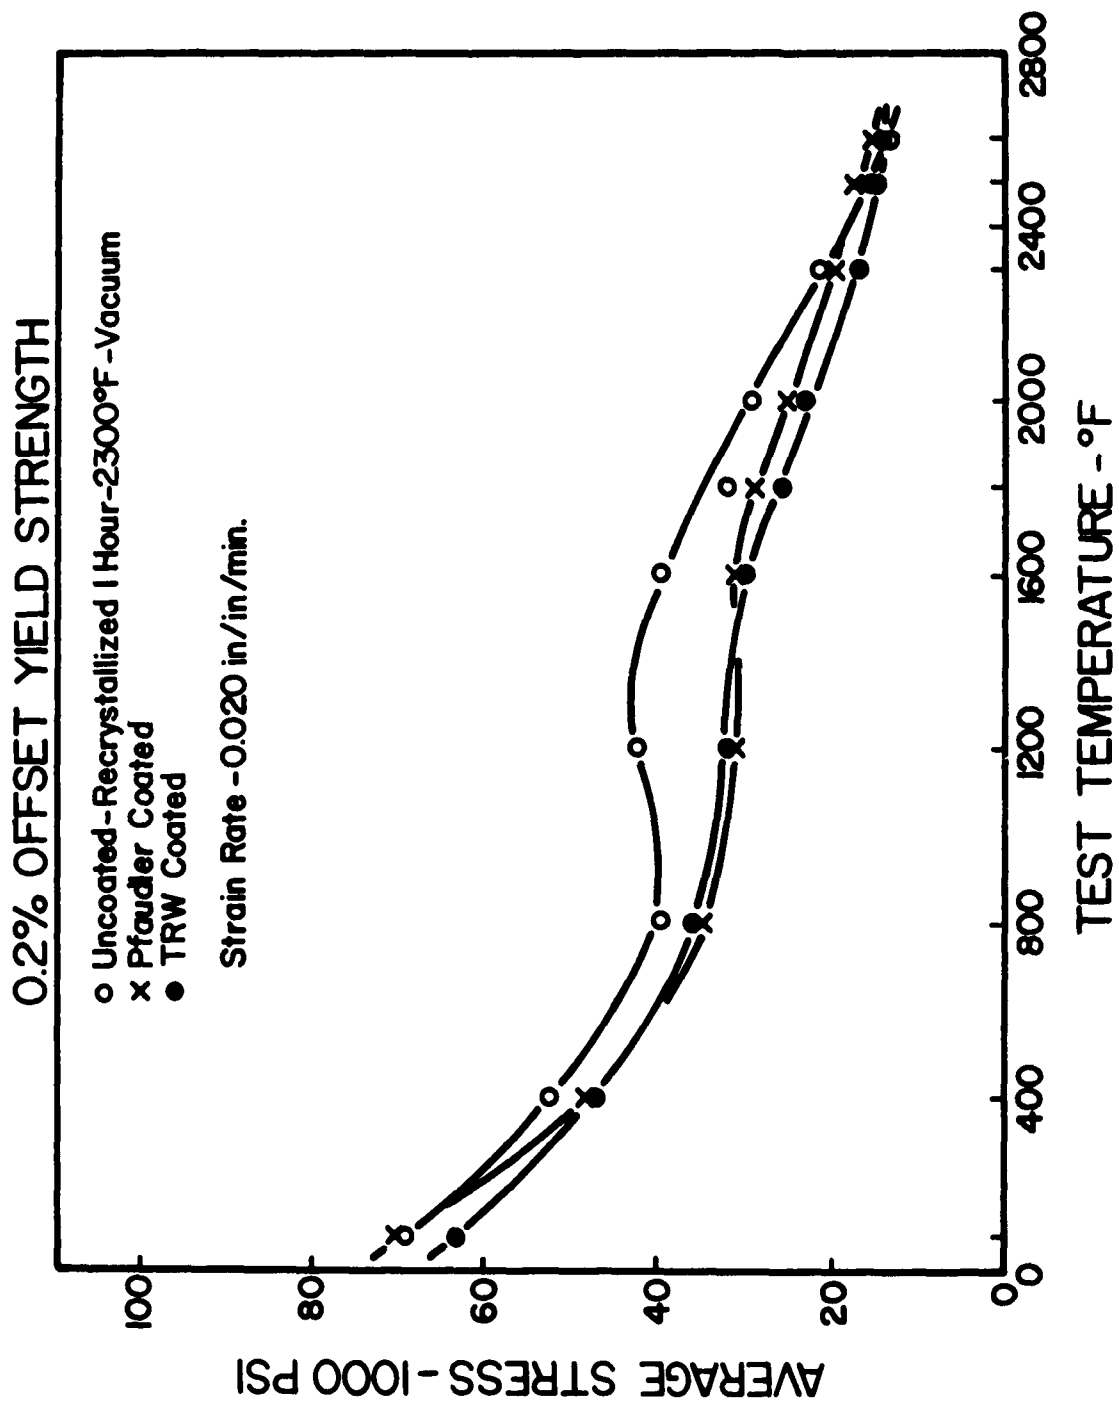
Figure 38 0.2% Offset Yield Strength of Uncoated and Coated 30 Mil FS-85 Alloy Sheet from Room Temperature to 2600°F
